INDOOR AIR QUALITY ASSESSMENT

**Henry B. Burkland Intermediate School
41 Mayflower Avenue
Middleborough, Massachusetts**

Prepared by:
Massachusetts Department of Public Health
Center for Environmental Health
Emergency Response/Indoor Air Quality
January 2005

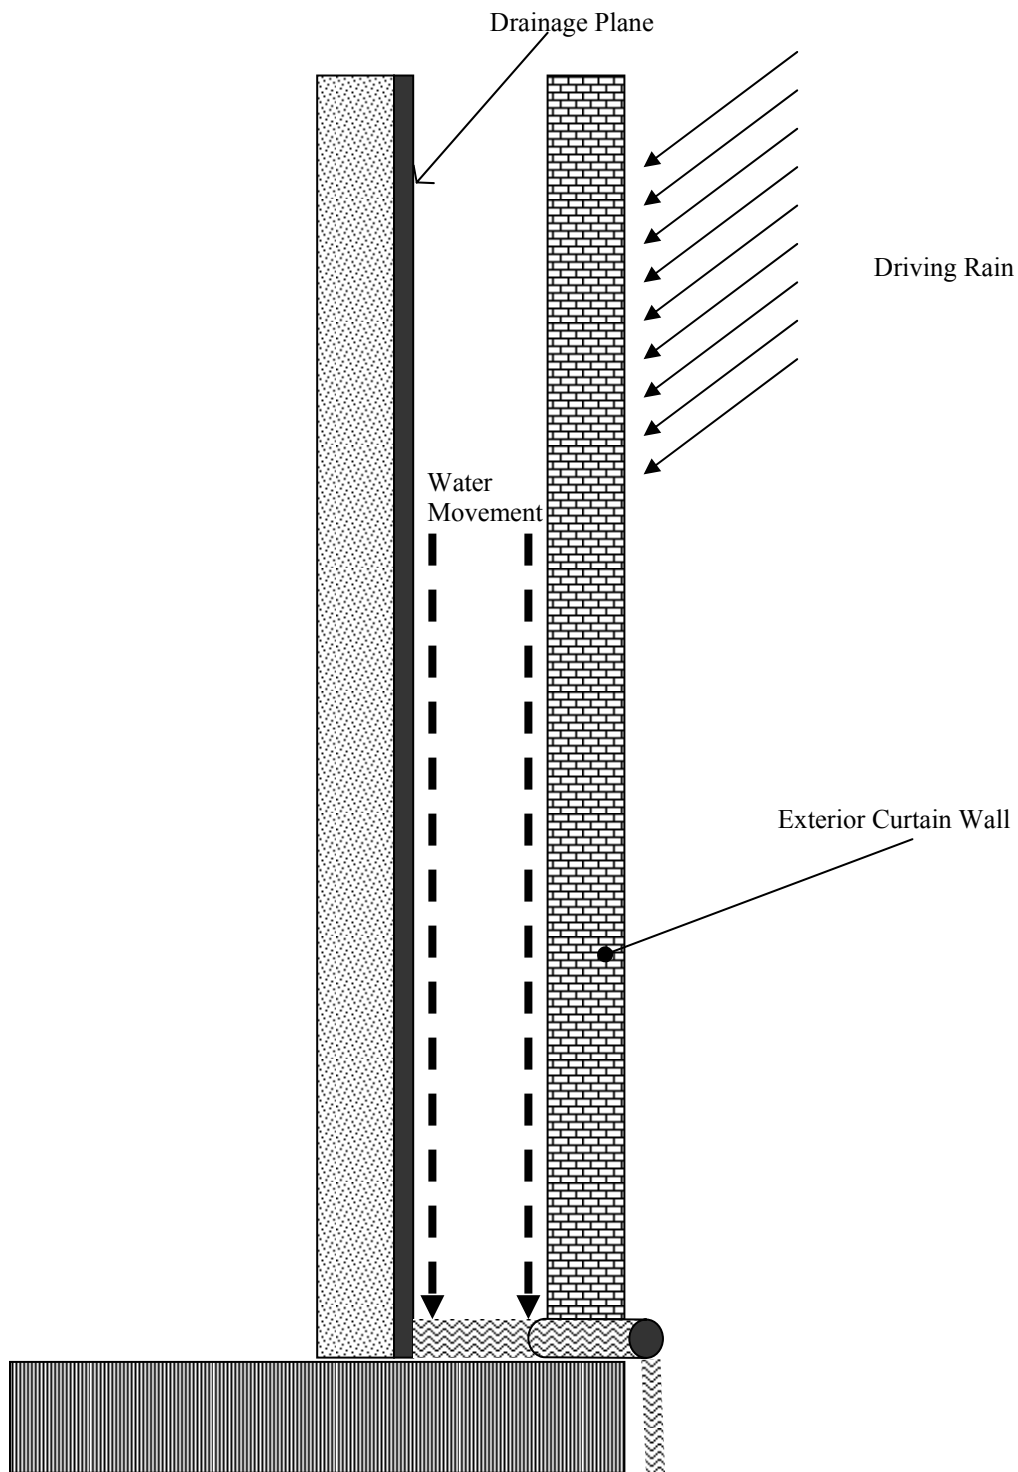
In order to allow for water to drain from the exterior brick wall system, a series of weep holes is customarily installed at or near the foundation slab/exterior wall system junction (Figure 2). Weep holes allow for accumulated water to drain from a wall system

Figure 2
The Function of the Drainage Plane and Weep Holes to Drain Water from the Wall System, Prevent Moisture Penetration into the Interior

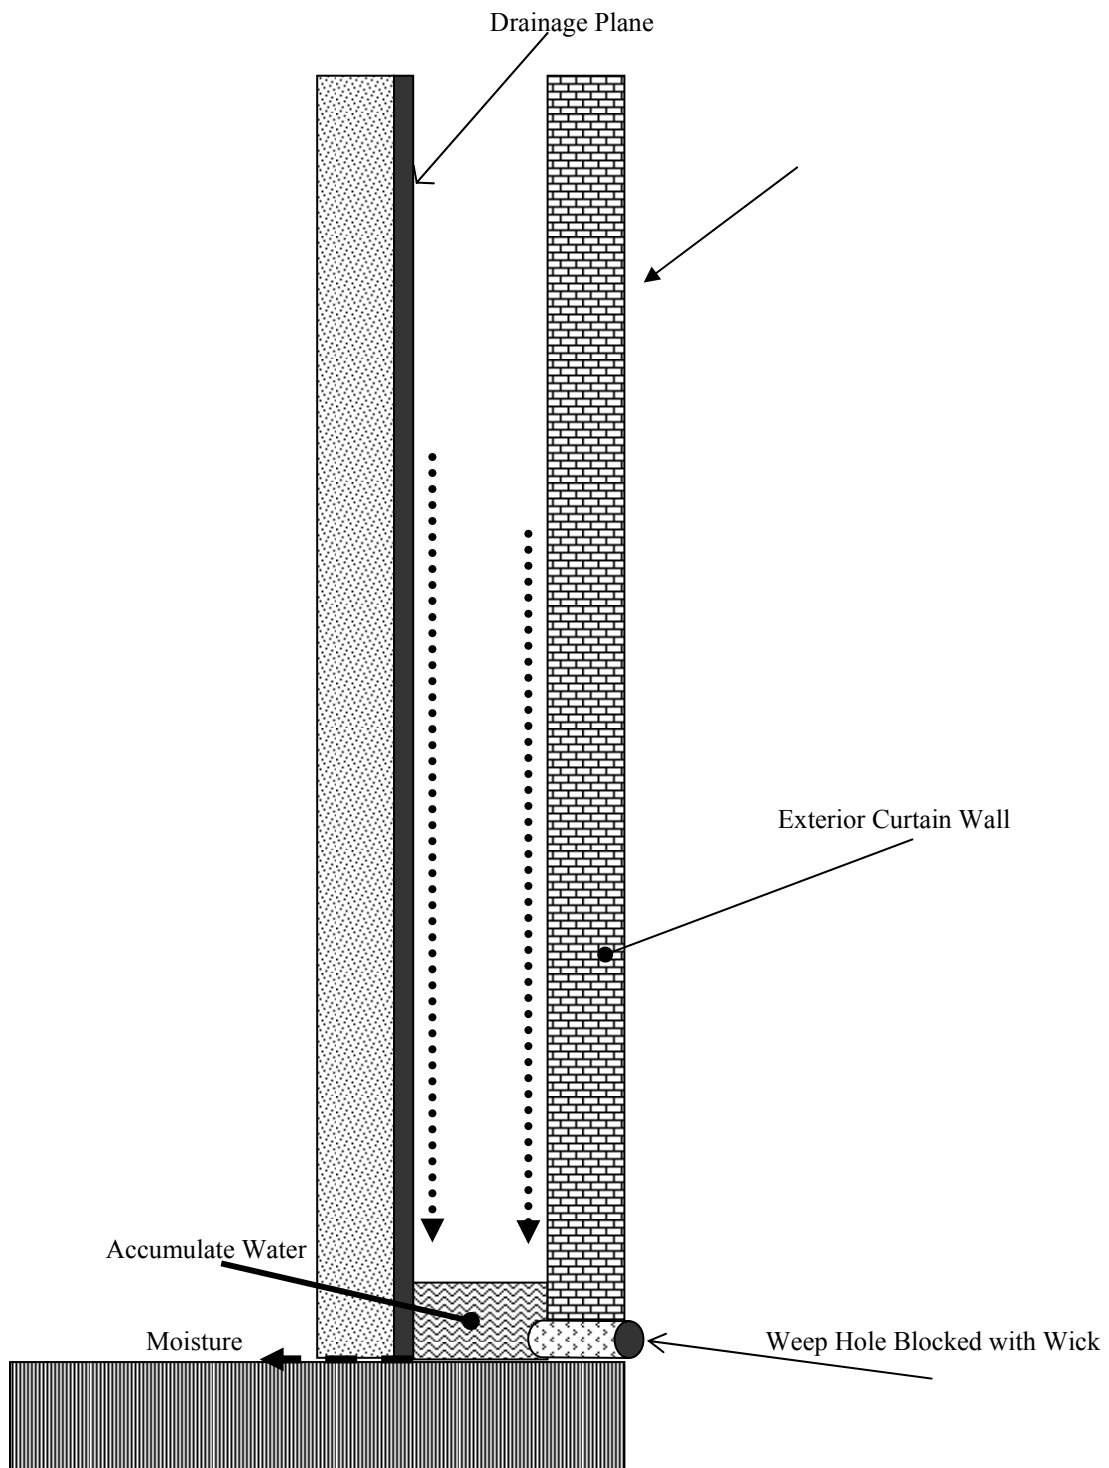
(Dalzell, J.R., 1955). Failure to install weep holes in brickwork or burial of weep holes below grade will allow water to accumulate in the base of walls, resulting in seepage and possible moistening of building components (Figure 3). The exterior of the BIS consists of a traditional red brick exterior wall. An examination of the exterior brick walls of the classroom 1-14 wing was conducted to identify the location and condition of weep holes. Weep holes were found approximately at the slab level. Of note is that each weep hole was blocked with a cloth/wick material. Wicks were originally installed to enhance water movement from the drainage plane. Over time, sediment accumulation turns the wick into a stopper, which prevents water drainage from the exterior wall system. It is not recommended to “use ropes or tubes for weep[hole]s” (Nelson, P.E., 1999).

Figure 3
Weep Hole Blocked with Wick and Water Accumulation in the Drainage Plane

1. Remove wicks from all weep holes and clear obstructions to walls to maximize water drainage from exterior wall systems. Install appropriate media in the weep holes to prevent insect migration.
2. Remove all obstructions from univent air diffusers and return vents to facilitate airflow.
3. Operate dehumidifiers during extended periods of hot, humid weather only. Ensure windows are closed during operation. Clean/maintain dehumidifiers in a manner consistent with manufacturer's recommendations.
4. For buildings in New England, periods of low relative humidity during the winter are often unavoidable. Therefore, scrupulous cleaning practices should be adopted to minimize common indoor air contaminants whose irritant effects can be enhanced when the relative humidity is low. To control for dusts, a high efficiency particulate
